Service Bulletin 471

P/N 146703-000A

Model Affected: MedSystem III® Multi-Channel Infusion Pump - 286X
Date: December 2000
Subject: Drive Module Assembly Motor with Date Code 448

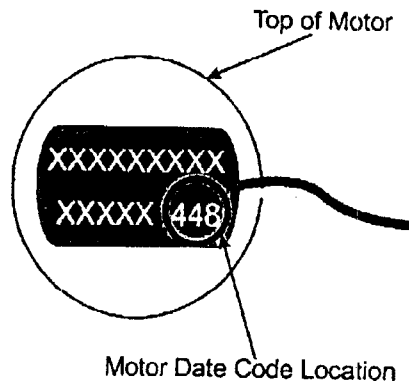
Figure 1 - Date Code Location on Drive Module Assembly Motor

Instruments, drive module assemblies and motor kits manufactured during the period of November 1998 to May 2000 may have a drive module assembly motor with date code 448. Drive module assemblies and motor kits having date code 448 may be subject to premature wear of the motor commutator. Wear in the commutator results in increased current draw from the motor. The Model 286X uses the motor current as an indicator of FSOD (Fluid-Side Occlusion Detection). The instrument may exhibit nuisance alarms and errors related to the drive mechanism, as indicated below.

9. Examine the date code on the drive module assembly motor. The date code is found on the black colored cover on top of the drive module. (*See figure 1*)
 - a. If the date code on the drive module assembly motor is 448, proceed to step 10.
 - b. If the date code on the drive module assembly motor is **not** 448, complete the troubleshooting process per the guidelines provided in the service manual and applicable service bulletins.

10. Replace the drive module assembly using the installation instructions provided as part of the drive module assembly replacement kit.

- Verify that the replacement assembly does **not** have a motor with date code 448.
- Ensure proper lubrication is applied to the cams of the replacement assembly. (*Reference Drive Module Assembly Repair section, 7.3.5; Reassembly step, c.2 - in Repair chapter of service manual.*)
